STAFF REPORT

SUBJECT: Call Box System Replacement Project

MEETING DATE: May 15, 2003

Attachment A Call Box Site Types

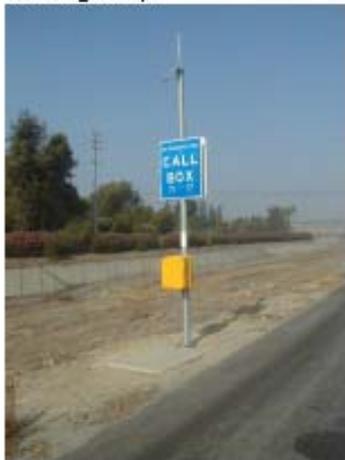
"A" site is on level ground or "at grade" and call box faces parallel to the highway.

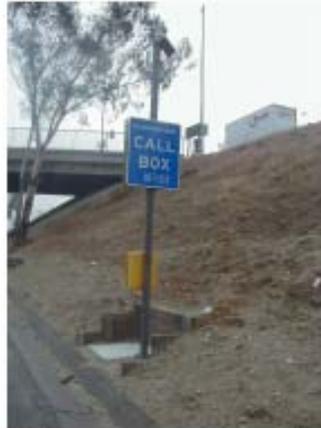
"B" site is on an upward slope and is "in cut" into the slope/hill. Most often requires transverse walls.

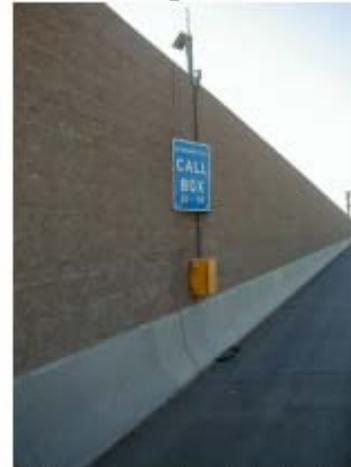
"D" site is directly mounted onto a sound wall or a retaining wall.

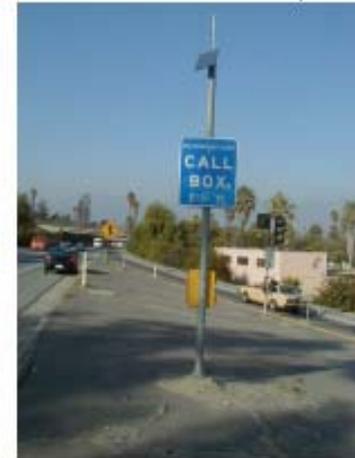
"G" site is on a paved median between a highway lane and an on/off ramp.

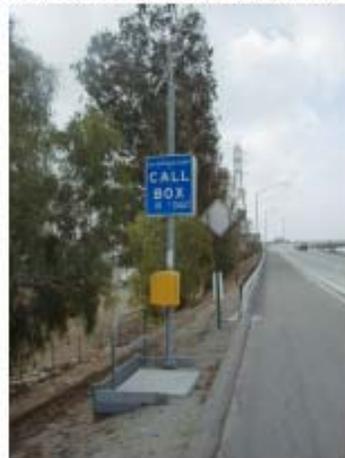
"C" site is on a down hill slope and has to be "in filled". Usually requires handrail/transverse walls.

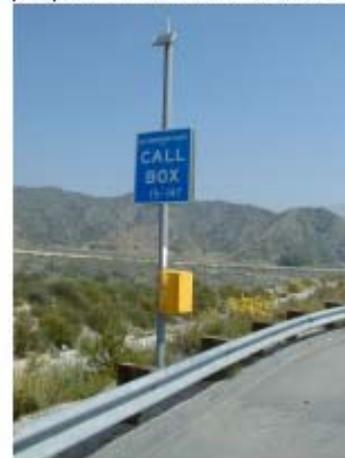
"F" site is placed behind a guard rail or another barrier and faces perpendicular to the road.

Note that Caltrans is evaluating the allowance for an "F" site to be placed behind a berm/dike, in addition to a guard rail and other permanent barriers.

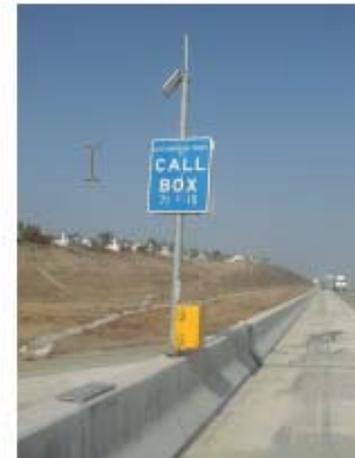
"H" site is mounted on top of a barrier wall or on permanently - mounted K-Rail.
